Dear Business Partner!

April 2013 a farmer in Austria showed interest in our FRONT-TURBO seeder and fertilizer spreader. Quickly we agreed with this deal and he informed about his special idea.

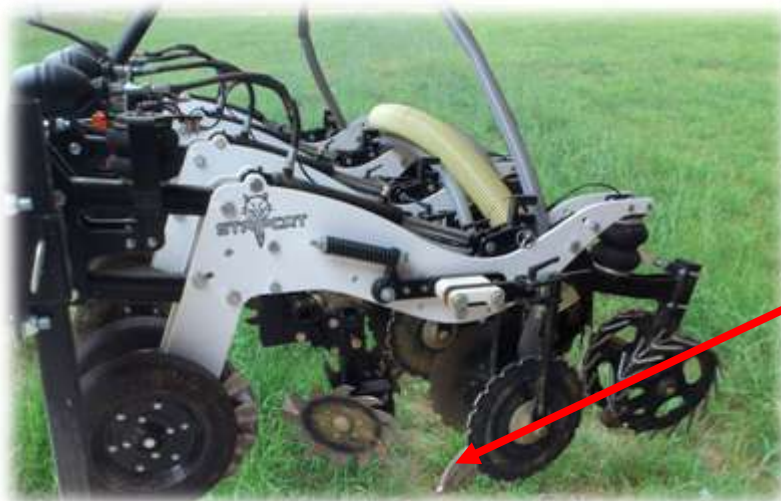
fertilization

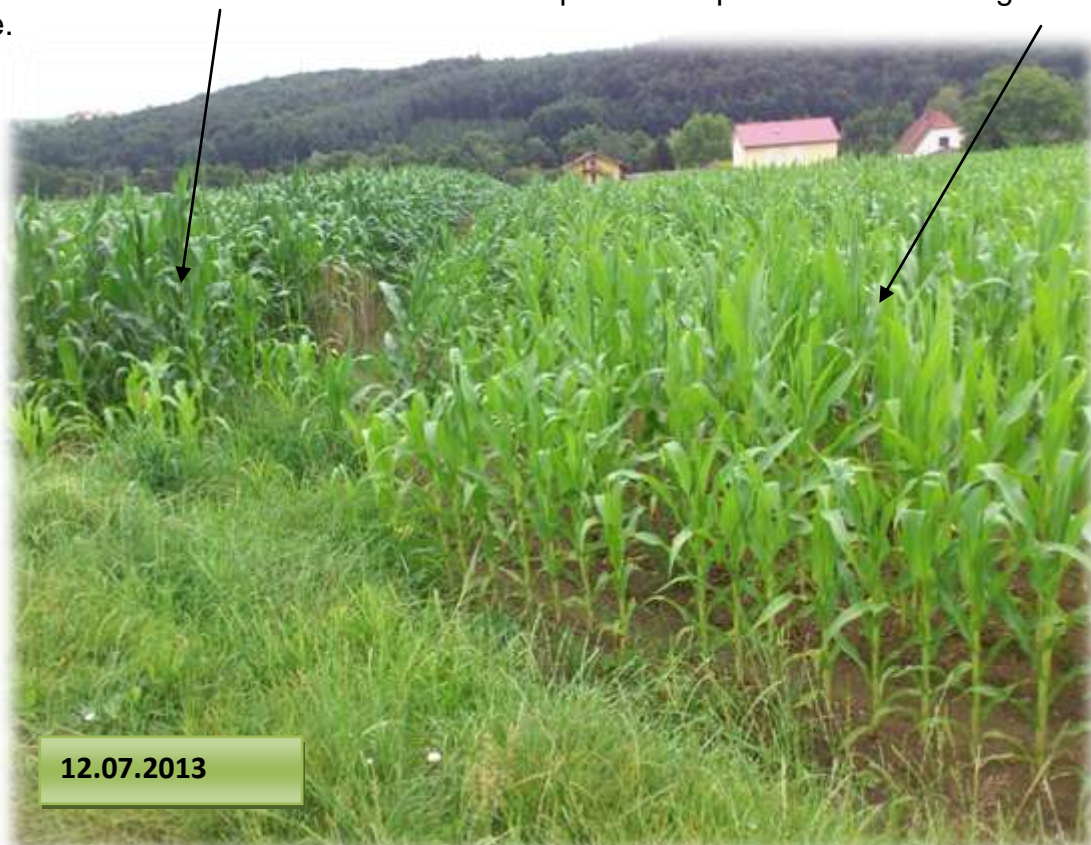
12.07.2013

The parcels left hand side shows a surprising development compared to the right side parcel.

Even with fertilizer use of 50% on left hand parcel compared to 100% on right hand side.

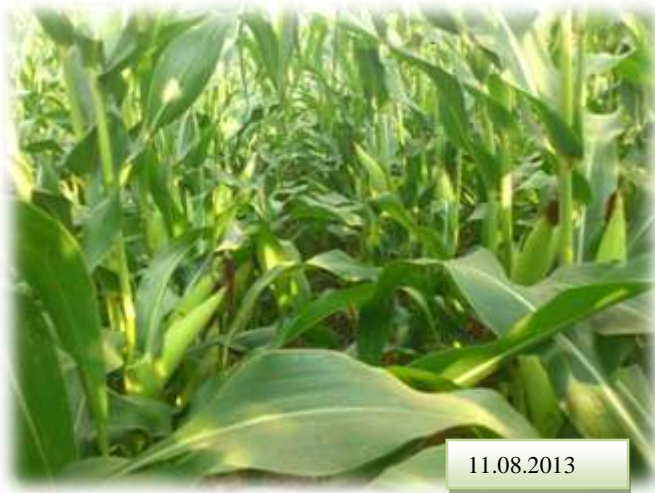
11.08.2013

Cultivation with STRIP CAT 50% Mineral fertilizer placed at 15-20mm deep behind the tine.

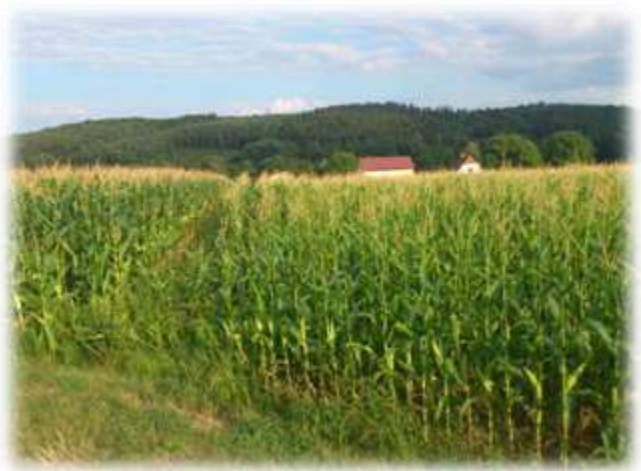
Cultivation with plough power harrow and 100% fertilizer even spreading.

Last year customer experienced very weak culture and dramatic erosion by heavy rain.

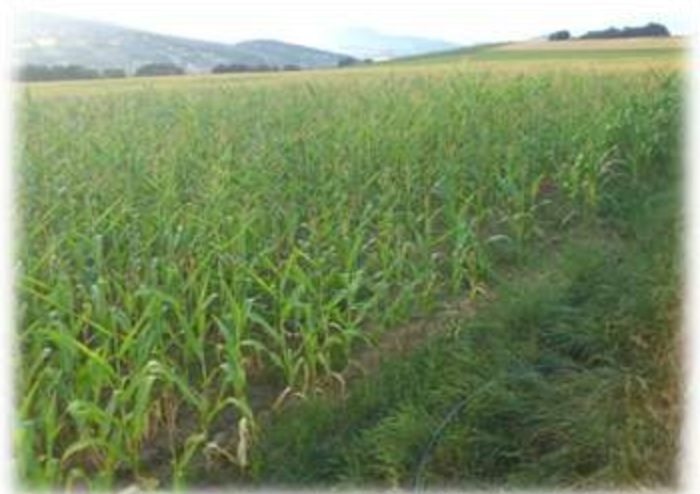
After last year Maize harvest customer seed rye corn for cover crop. Early may 30-40 cm high crop was pressed down by a roller before STRIP TILL cultivation.

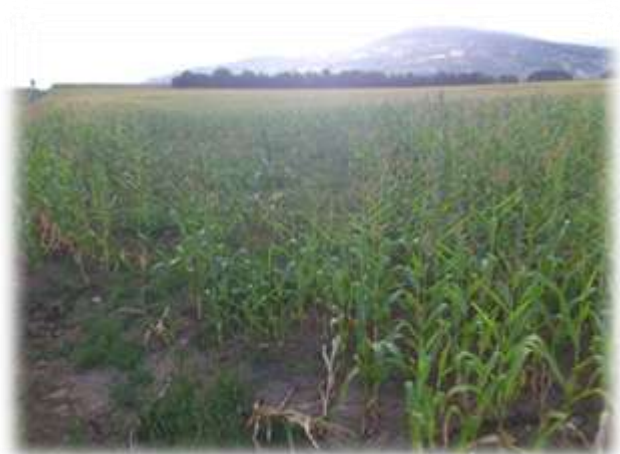
11.08.13 Erosion has removed soil and fertilizer

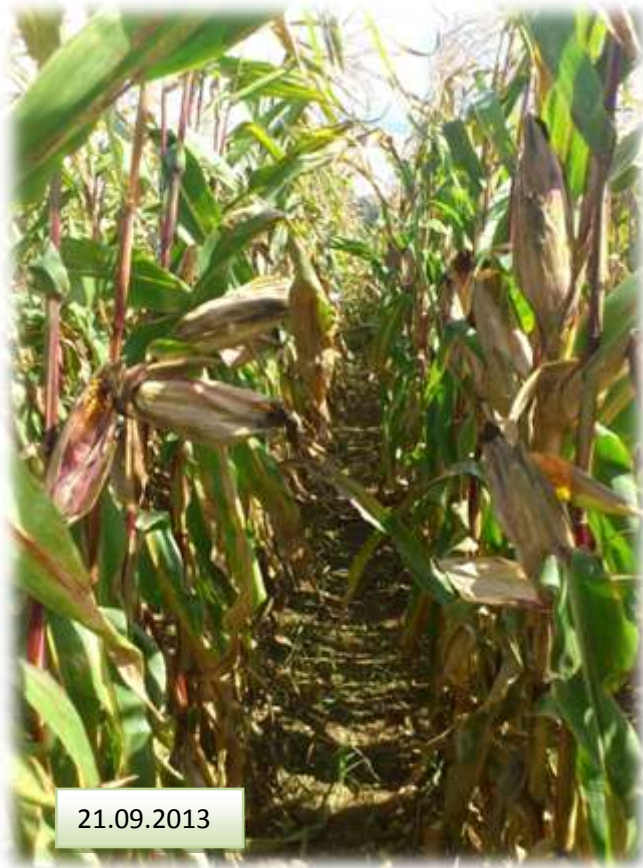
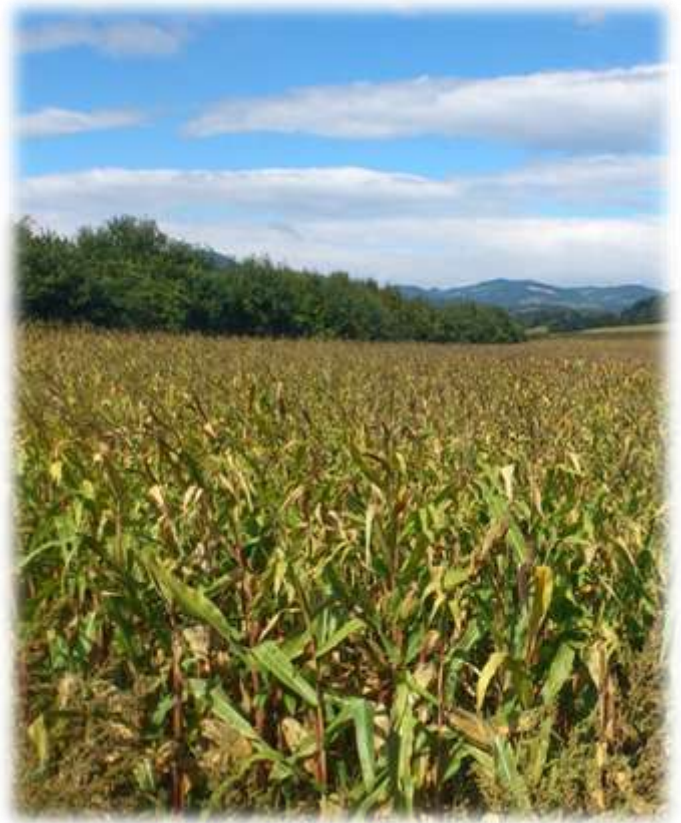
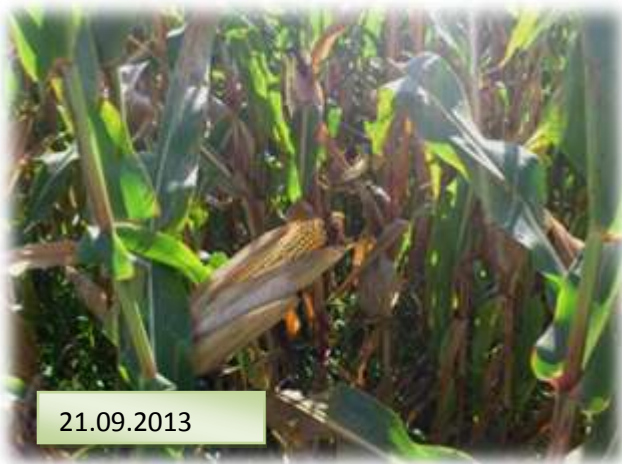
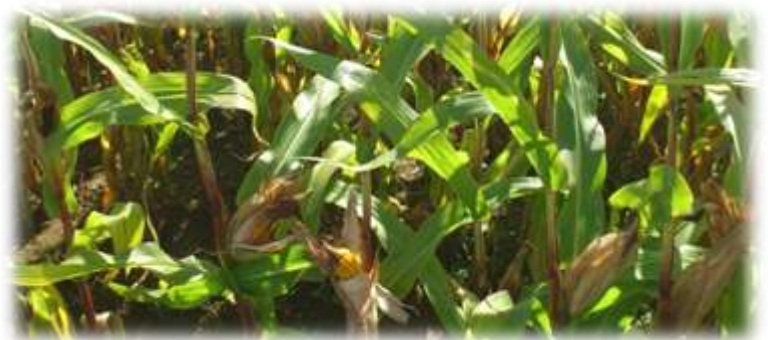
Due to placing the fertilizer behind the tine into deeper soil section the “N” in gased condition developend full activity.

The reason to reduce fertilizer at start was, to spread the second part during row cultivation when the crop is about 20-30cm high.
